MIPS R4400PC/SC Errata, Processor Revision 1.0

February 9, 1994

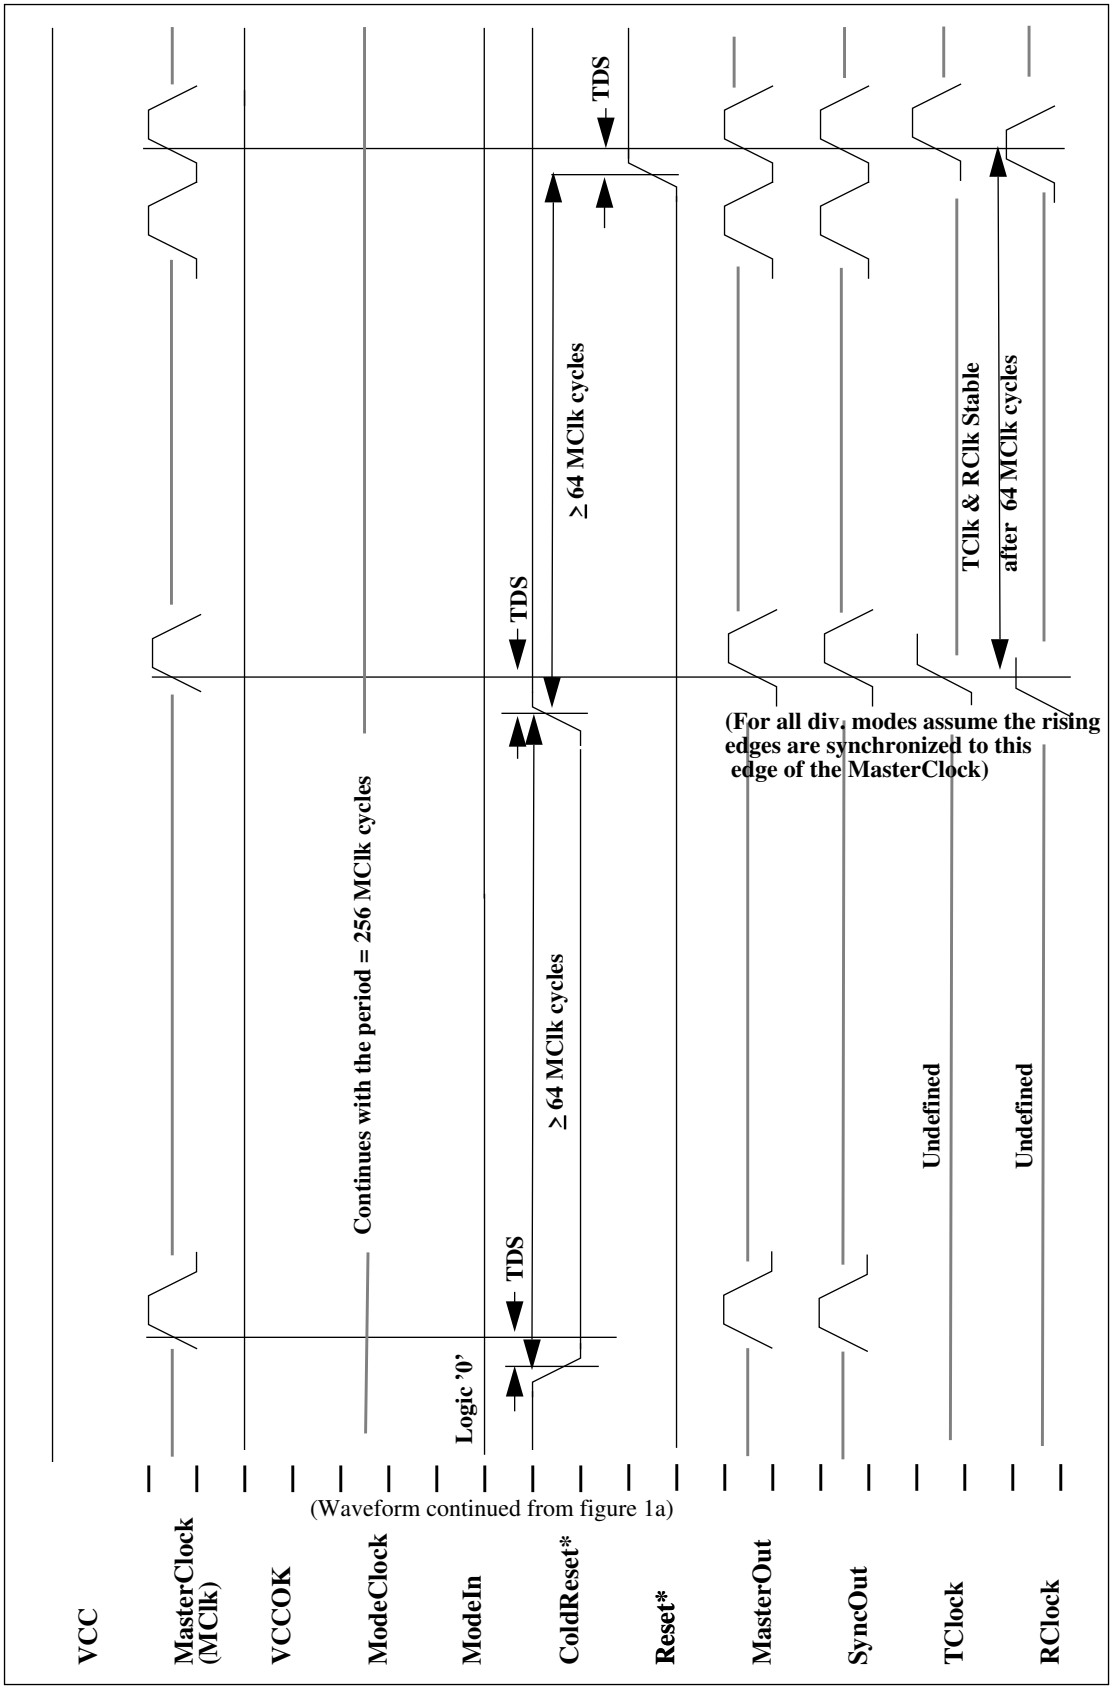
Figure 1a: Power-on Reset or Cold Reset - Workaround for Bug# 22

22. R4400PC, R4400SC: During the power up sequence, the period of TClk and RClk may not be as expected for at least 1024 MasterClock cycles following the de-assertion of ColdResetB. The above bug is true for all system interface divisors. Furthermore, if the system interface divisor other than 2 (i.e. 3,4,6 & 8) is used, TClk and RClk's rising edge may not align to the rising edge of the MasterClock, as specified.

This may not be a problem for systems using only TClk for the external logic. However, certain systems like -

1) systems using MasterClock for the external logic
2) system with external PLL which needs to lock with the internal PLL
3) systems with multiple processors operating in lock-step

this bug may cause problems.
Thus, for system with interface divisor set to two, the only violation will be that the TClk and RClk's period might not be valid within 64 MasterClock after the ColdResetB is de-asserted.

Workaround:Assert a second ColdResetB after at least 1024 MasterClock cycles from the de-assertion of the first ColdResetB. ResetB should remain asserted until at least 64 MasterClock cycles following the de-assertion of the second ColdResetB. TClk and RClk will then be valid 64 MasterClock cycles after the de-assertion of the second ColdResetB and their edge alignment with respect to MasterClock will be as specified. Figure 1a & 1b show the waveforms in more detail. Note that the waveforms in Figure 1b are continuation of the those in figure 1a.
