Prepared by:
Network Storage Solutions
Hewlett Packard Company

Upgrading the MSA1000 for Enhanced Features

***Abstract:** This white paper outlines step-by-step procedures to upgrade an MSA1000 and its components to enable enhanced features*

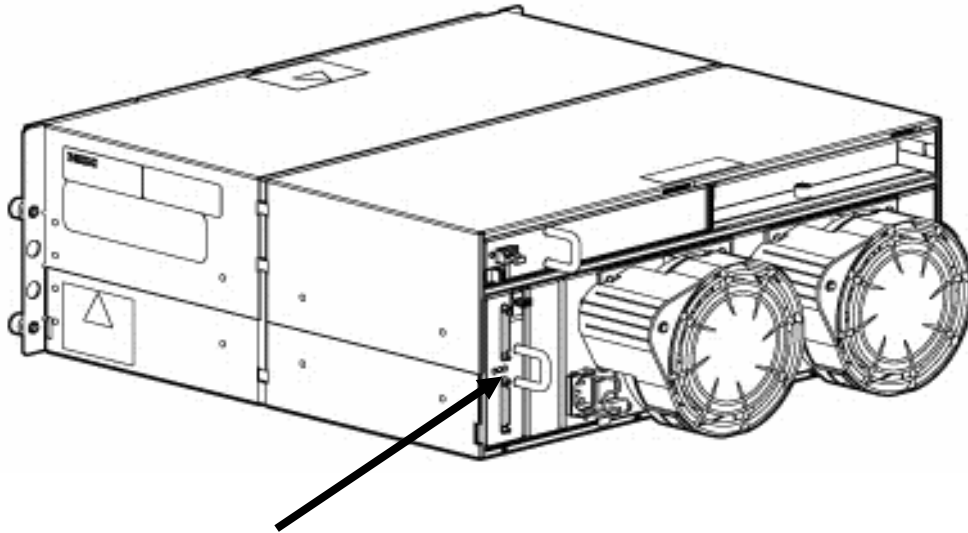
To determine the manufacturer of the EMU in the MSA1000, the MSA1000 will have to be powered off (make sure there is no I/O running from a server to the MSA1000 before powering it off). At the back of the MSA1000 chassis, remove the SCSI cables (if attached) on the SCSI Interconnect board (located on the left of the MSA1000 unit) – see drawing below:

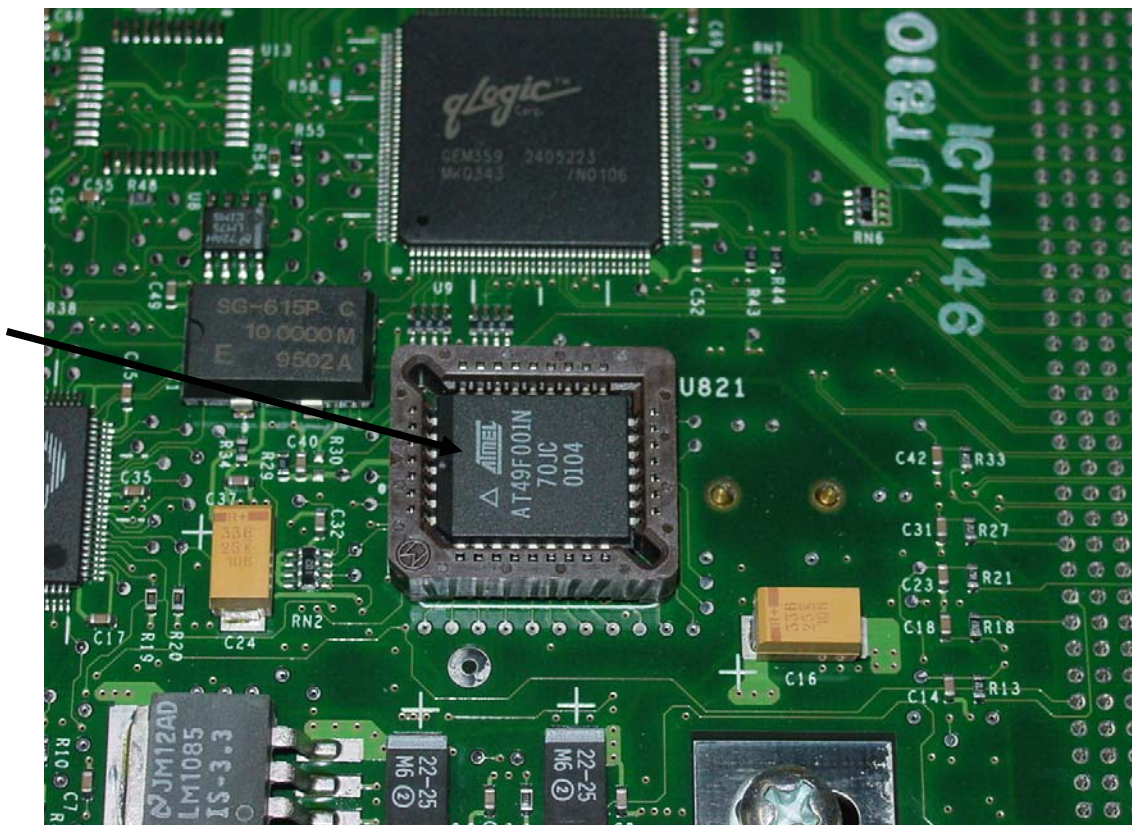
Once the cables have been disconnected, remove this card from the back of the MSA1000 chassis by simultaneously pushing down on the quick release latch mechanism and pulling the card out. Once the card is out, set it down on a flat surface, metal part of the card face down. If the SCSI ports on the card are facing to the left, the EMU EEPROM is located towards the bottom right section of the printed circuit board. It is the only chip on the board that is located in a solder-less connector.

Once the chip is located, look closely at the wording on the chip. If the chip reads **AMD**, this chip is flashable, and the upgrade procedures can continue. **If the chip reads ATMEL, this chip is NOT flashable. Please call HP Customer Services to have this board replaced.**

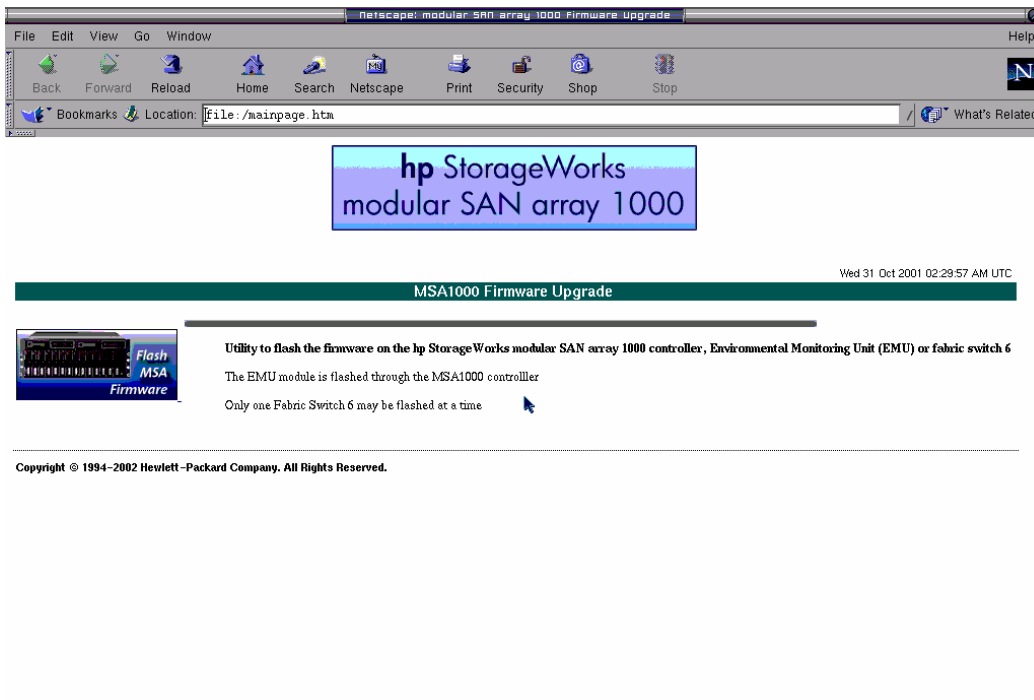
The first step involved in flashing the MSA1000 firmware is to power down all servers that are connected to the MSA1000. Please follow appropriate methods to bring down applications, servers, clusters, etc. Place the MSA1000 Firmware Upgrade CD in a server's CD ROM drive (that is connected to the MSA1000), and power up the server. The server will boot to the MSA1000 Firmware Upgrade CD. When the utility is fully booted, the MSA1000 utility screen will appear with the options to flash the MSA1000 firmware, the Environmental Monitoring Unit, or the Fabric Switch6 (if installed).

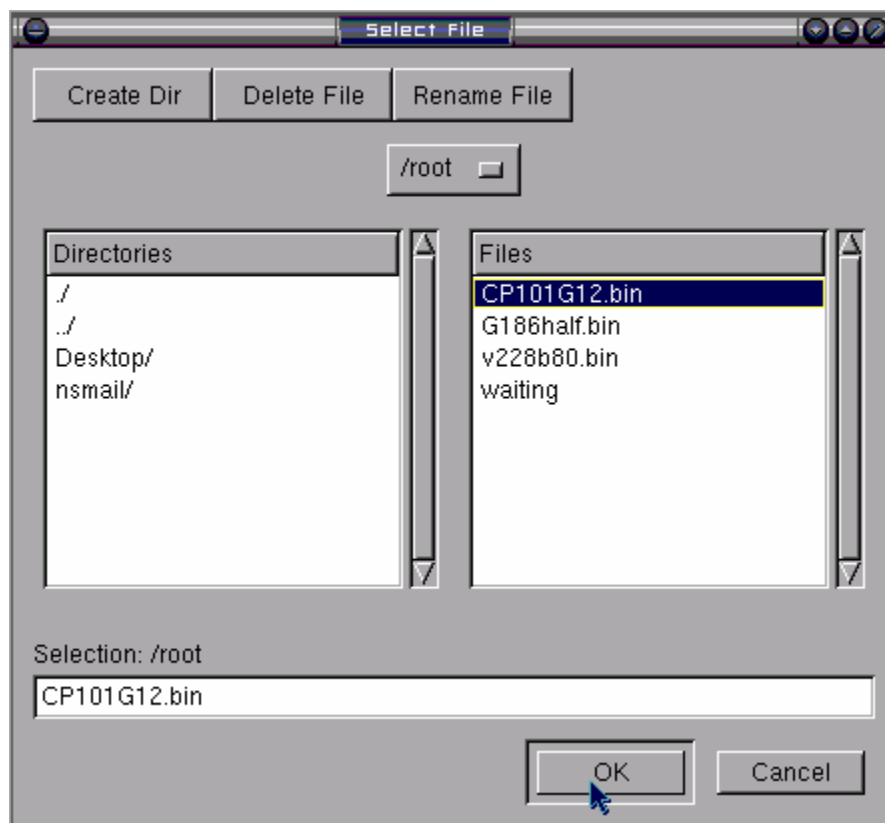
5. The next prompt is for the switch firmware upgrade source file. By default, the listing is from the CD. Highlight the firmware file (in this case CP101G12.bin), and click on the **OK** button.
